Report on the investigation into the fire in the engine room  
of  
FERNANDA, IMO No. 7806025  
off the coast of Iceland  
on  
30 October 2013

Commonwealth of Dominica  
Maritime Administration

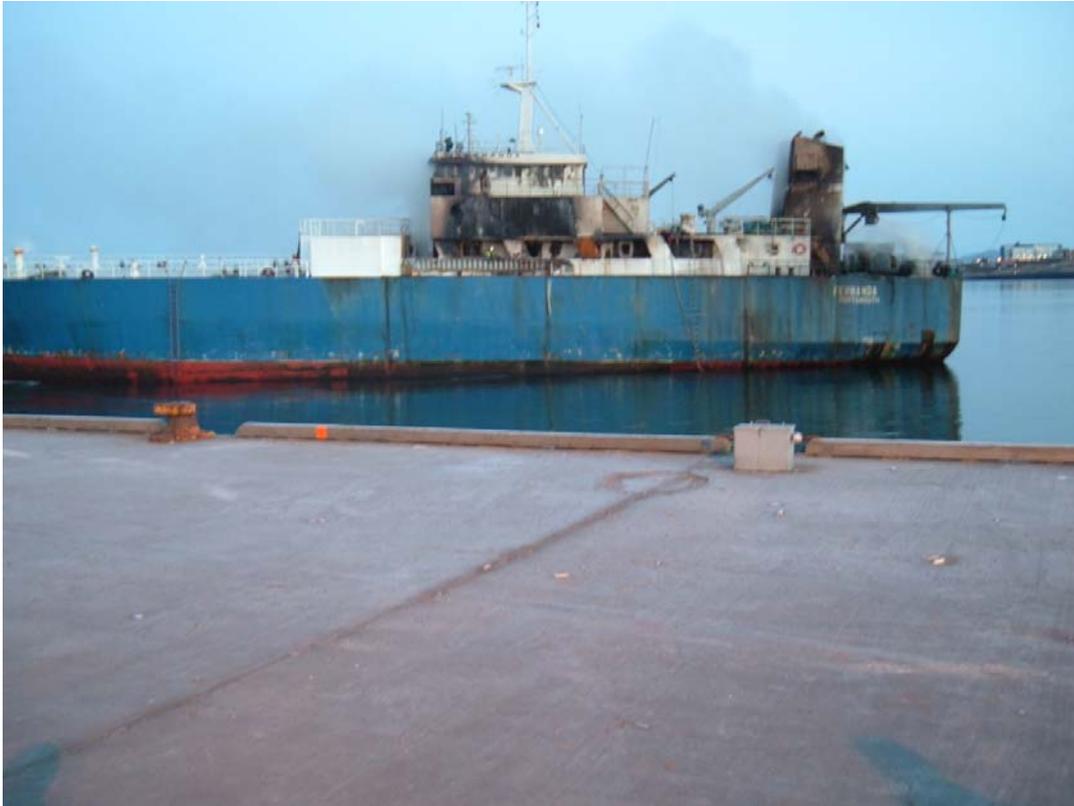
FERNANDA arriving at Hafnarfjordur, Iceland showing extensive damage on aft part

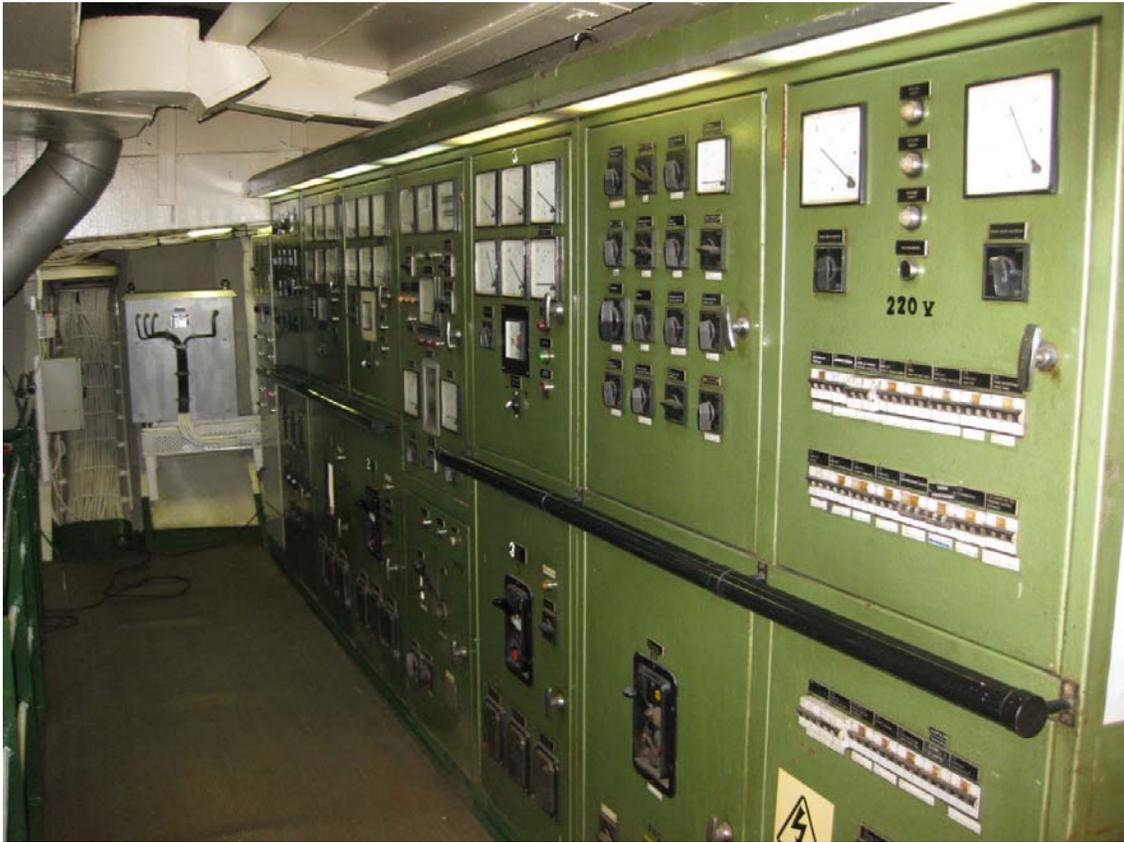
**Switchboard on FERNANDA**

The switchboard was extensively damaged in the fire although it was not possible to identify the cause of the fire. The manufacturers name is not known and following the

fire no manufacturers manual exists. Maintenance of the switchboard consisted of cleaning and checking connection tightening and was last carried out in April 2013.

It is believed that the fire originated in the electrical switchboard located across the after end of the engine room. No proximate cause could be determined. The fire burned intensely in the switchboard area being fed by air drawn in by the chimney effect of the open funnel fire dampers. The Halon fixed fire-fighting system was activated and the Master believed that it did initially suppress the fire to some extent. However the effectiveness of the Halon was adversely affected by the flow of air through the engine room and the fire continued to grow spreading into the funnel spaces and igniting the oil in the cargo crane hydraulic header tank in the starboard

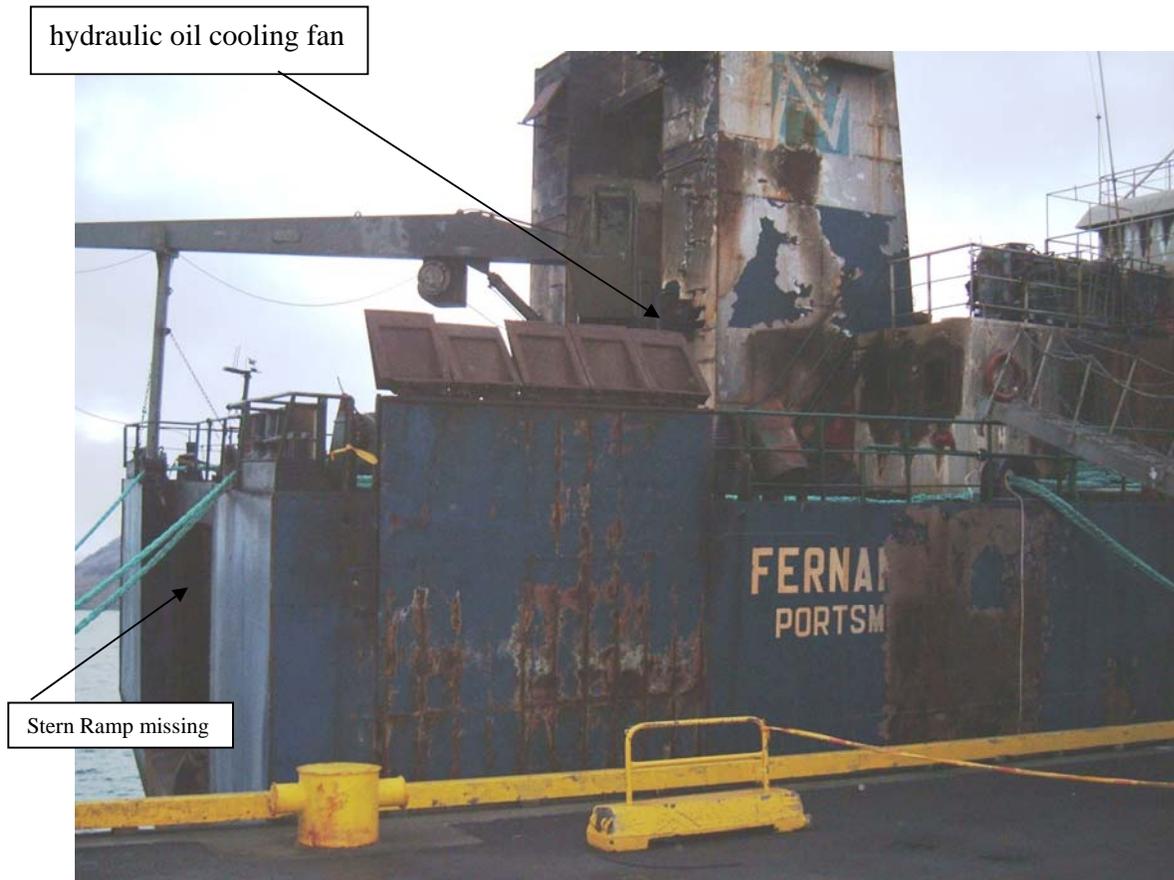
The HALON fixed fire-fighting system appears to have been satisfactorily released in the machinery space. Most fire dampers on board were closed by the crew before the release, however there was one fire damper on the aft end of each funnel that was not closed. In addition, there was a hinged access door into the refrigerating plant at the aft end of the cargo hold which was found tied back. This area was not directly affected by the fire but would have provided an air supply to the engine room at the lowest level thereby aiding the development of the fire and reducing the effectiveness of the Halon.

The open fire dampers were noted on FERNANDA's arrival in Hafnardsfordhur. The dampers are hinged on the upper side and are maintained in the open position by two bars on each damper attached to the funnels on their lower sides. The only method of closing such dampers is by climbing a series of unprotected rungs attached to the aft end of each funnel to release the bars, close and secure the dampers.

Accessing these fire dampers would have been hazardous at any time as the rungs are not of the same size and are not in one straight line. Given the rapidity of the development of the fire it is likely the rungs and the funnel would quickly have been at a high temperature and in the prevailing sea conditions which, according to the Master caused the vessel to roll heavily, it would have been foolhardy even to attempt to close them. To further complicate matters, on the starboard funnel a cooling fan for the hydraulic oil supply to the aft mooring winches had been fitted between the ladder rungs. ( *See photograph on page 23*)

Fire Dampers on funnels – note the hydraulic oil cooling fan on the starboard funnel

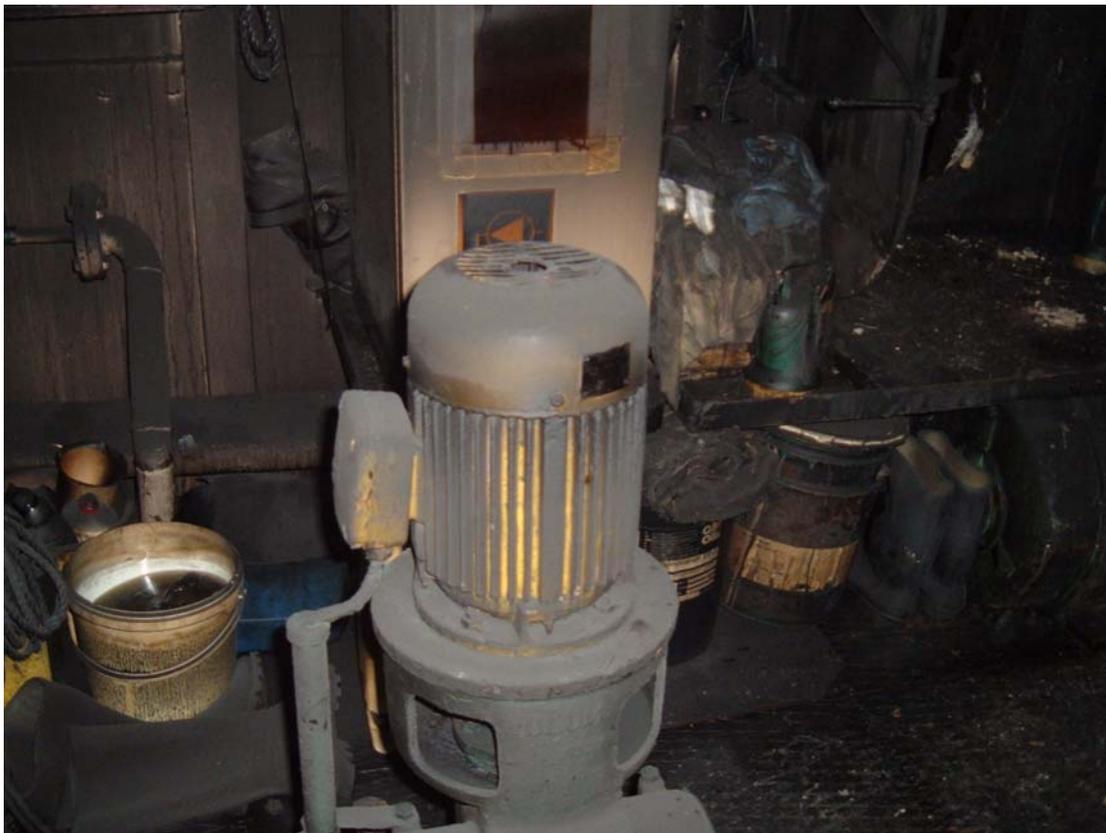
Good housekeeping is an important aspect of effective on-board management of risks, ensuring the crew's wellbeing and safety. During the post-fire inspection of the machinery spaces some examples of poor housekeeping were noted. Oils, oily rags, rubber boots and other garbage were found lying around the machinery spaces. A hose was fitted to the drain from the save-all around the oil purifiers to divert its contents into the engine room bilges.

While it may be a matter of convenience, the random oils, rags and rubber boots present both fire and health hazards. Measures should be taken to ensure that all such materials are kept in a safe, approved stowage away from the machinery spaces and that garbage such as oily rags, rubber boots and gloves, etc. are removed to the garbage stowage area on a daily basis.

Oil drums, boots and other rubbish in Forward Port Engine room. ( Note open entrance to refrigeration machinery space top right)

Housekeeping issues resulting in oil drums, oily rags and other garbage in the engine room may have contributed to the development of the fire based on the history of housekeeping issues during inspections as well as evidence observed in areas of the engine room unaffected by fire during the post fire inspection.

- publicising the details of this fire, highlighting the need to maintain high housekeeping standards in machinery spaces, particularly in the engine room;
- recommending that statutory drills are planned to achieve specific objectives such as closing down all accesses to the engine room or removing a casualty from the engine room; and
- recommending that at the conclusion of each drill its progress should be reviewed to highlight what went well and identify what could have been improved.

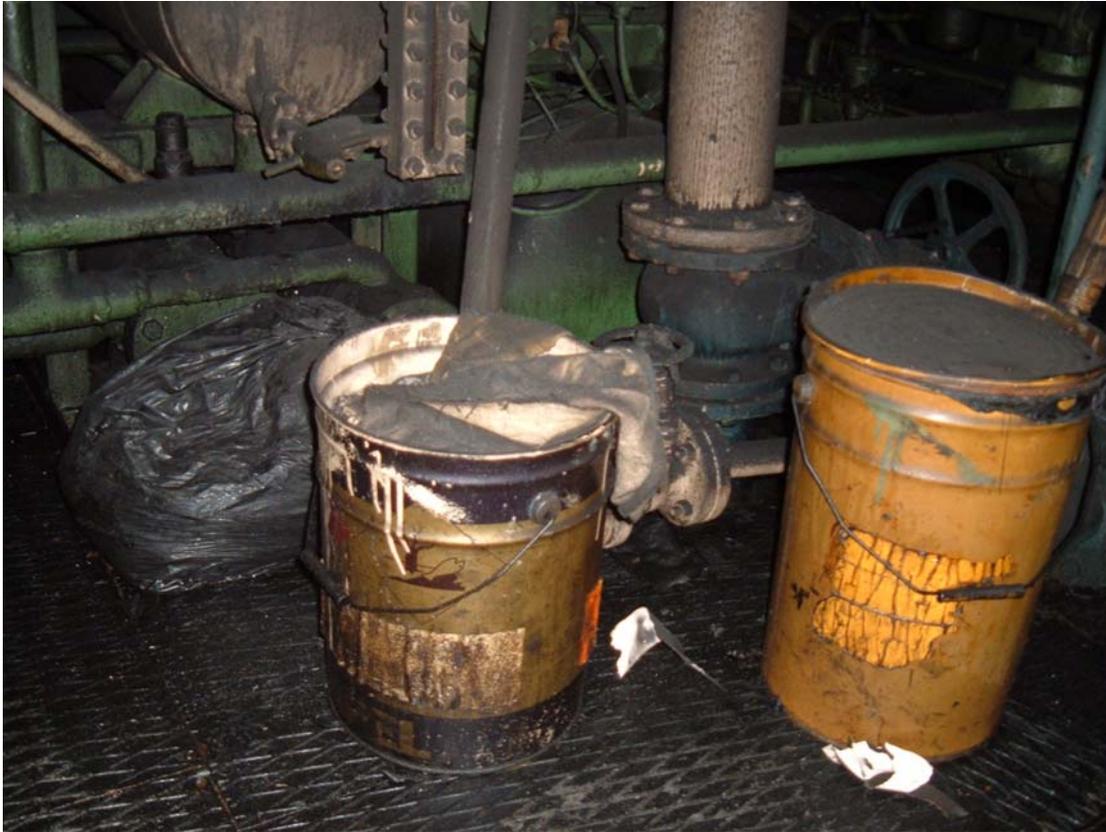
Two drums and a parcel of oily rags
